**JOURNAL OF THE ROYAL LAUREATES ACADEMY**

## **INTEGRATED HERITAGE CONSERVATION AND TOURISM – LED URBAN REGENERATION OF NAGAR KASBA IN MIRKADIM, MUNSHIGANJ, BANGLADESH**

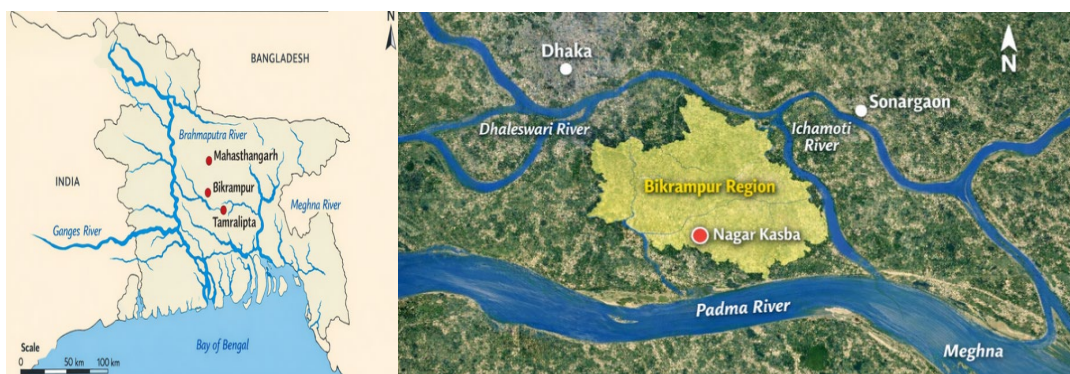
**Fig. 01 & 02 :** Geographical Location of Nagar Kasba at Mirkadim in the Bikrampur Region; This Map is Prepared by ArchGIS and RS & Major river routes and early urban centers in Bengal

The civilization of the "Nagar Kasba" has developed around the rivers. This pargana is surrounded by the historical Dhaleswari, Padma, Meghna and Ichamati rivers, which are surrounded by numerous small and large canals, ghats and markets. The development of this pargana during the Sultanate period, which has been under Mughal and colonial rule from time to time, has existed until the present day. Here, in all eras, the communication system has played an important role in regional and international

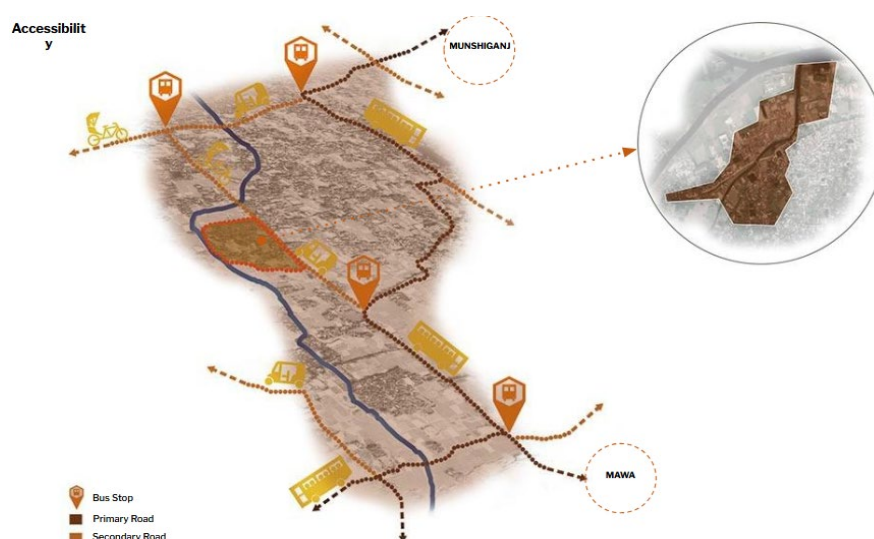
**Fig .04 Shows:** *Accessibility in Nagar Kasba from Various Angles, Including Primary and Secondary Roads and Street-front Houses.*

Nagar Kasba can currently be reached from the Dhaka–Munshiganj regional road by using Mirkadim’s municipal road system, which leads to secondary roads and narrow local paths. The adjacent heritage landscape encompasses Kamalaghat, Kazir Kasba, the historical Mirkadim river-port and marketplace, Idrakpur Fort, Baba Adam Mosque and Tomb, the homestead of Raja Ballal Sena, Rampal Dighi, and Panditer Bhita located in Bajrayogini. Collectively, these areas offer chances to build an interconnected heritage and cultural tourism path. However, road classification, public transport stations, pedestrian pathways, riverbanks, accessibility conditions, distances, and property lines must be confirmed through field observation and GIS analysis before the location map is deemed final (A. M. Chowdhury, 2021; Ghosh, 2023).

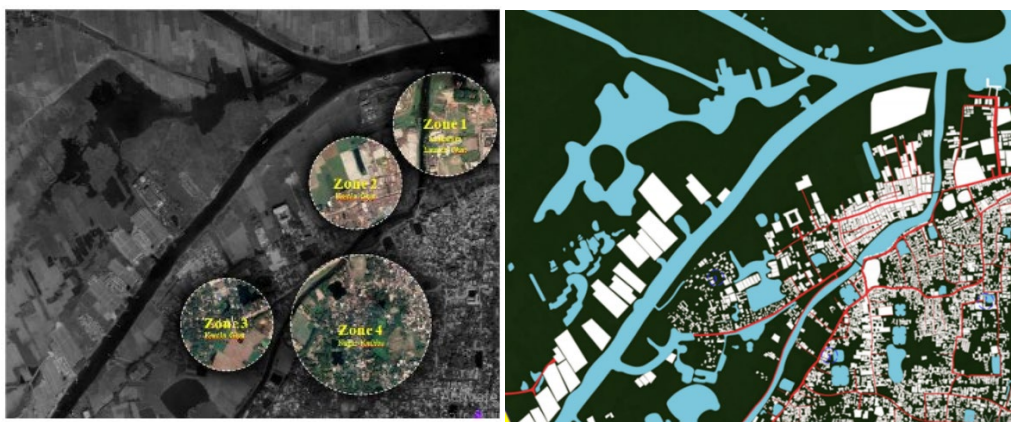
*Fig.05 & 06 Shows: Sites and Site Surroundings of Nagar Kasba*

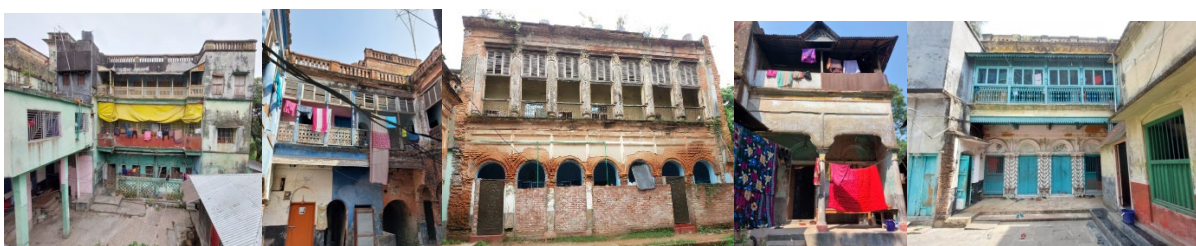
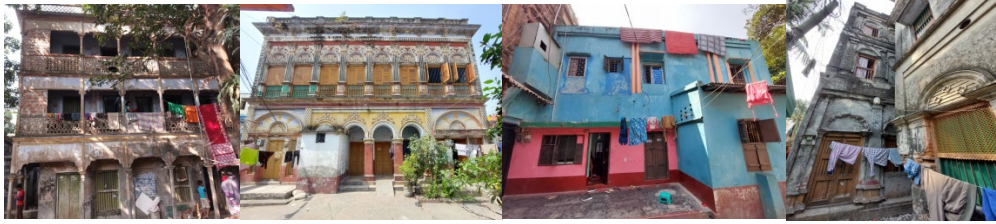
*Fig. 08 Shows: Different Types of Houses at Nagar Kasba Such as – Surujjamal Bepari House (Back Side), Bag House, Haque House, Dyanda Kabiraj House, Surujjamal Bepari House (Front Side), Rohit Dash House, Boro Podder House, Kali House, Dutta House and Bainna House.*

Based on size, shape and spatial arrangement, the residential buildings of Nagar Kasbah can be mainly divided into two types—1. Courtyard-centered houses 2. Bungalow-type houses. One of the characteristics of the courtyard-centered houses of Nagar Kasbah is the presence of two separate courtyards. The first or outer courtyard was used for public and semi-public activities, while the second or inner courtyard was reserved for family and private activities. Bungalow-type houses do not have the presence of an internal central courtyard. They are usually single-storey or double-storey buildings with open courtyards in front or behind. No specific consistency or uniform plan is observed in the layout of these buildings (Alam, 2021).

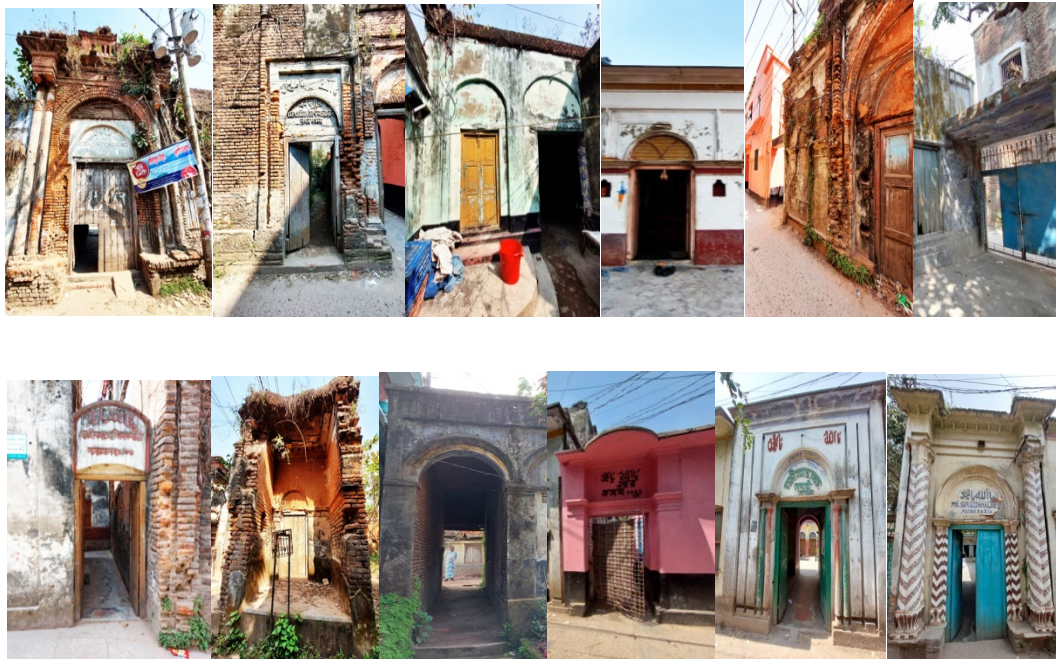
**Fig.09 Shows:** Main Entrance of Laxmi House, Swarno Kutir House, Bhuyan House, Vubon Mohon Podder House, Haque House, Choto Dewan House, Kali House, Haji Abdul Hamid House, Radha Madhab House, Subhash Chandra House, Choto Bepari House, Boro Podder House, Surujjamal Bepari House, Dudu Mia House Elevation.

The common physical features present in the buildings of the urban city play an important role in understanding their architectural and spatial arrangement. In particular, the courtyards defined the various functions and functional areas of the house. In most courtyard-centered houses, the front block facing the street was used as the main entrance. It also served as a place for holding public or semi-public events. The rooms located around the front courtyard were usually used as temples, guest rooms, living rooms and dining rooms. At the same time, processions, folk music, folk dances and various social and cultural events were organized in this courtyard. The second or inner courtyard was connected to the front part by a connecting path. It was mainly used for the private activities of the family. The bedrooms and other private rooms were built facing this courtyard. Canopied walkways formed by rectangular or circular arched pillars surrounded the courtyards. These paths provided access from one room to another as well as protection from the sun and rain. Behind each house was a service area adjacent to the boundary, where the kitchen, the kitchen-adjacent garden, toilets and other household facilities were located. These parts behind the house were connected to each other by a narrow alley. Most houses had two separate entrances at the front and back, so it was possible to travel from both directions. There were ponds for the joint use of the residents along the settlement path. Beyond this, a canal surrounded this residential area of the elite merchants. On the one hand, the canal served as a waterway for the transport of people and goods, and on the other hand, it played the role of a natural moat to ensure the security of the settlement. As a result, a well-organized combination of residential, social, cultural, domestic and security activities can be observed in the overall spatial layout of the urban settlement (Alam, 2021; Tweed & Sutherland, 2007).

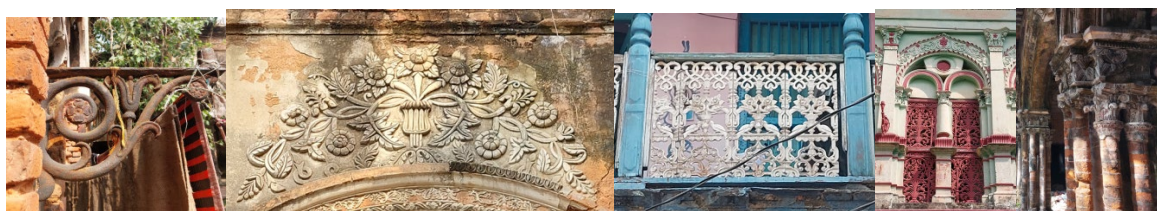
**Fig.10 Shows:** Building Ornamentation and Decorations Systems in Nagar Kasba

The houses in Nagar Kasba feature decorations blending European, Mughal, and Bengali styles, mainly on entrances, verandas, columns, and windows. They display segmental arches, carved timber doors, patterned shutters, and verandas with arches around courtyards. These decorations indicate the wealth of merchant families and were crafted using brick, lime plaster, and timber by local craftsmen. Despite damage, they reveal skilled craftsmanship and architectural richness, representing a unique mix of styles that make Nagar Kasba houses special and a valuable heritage. Many are weathered or repaired poorly, but their beauty endures.

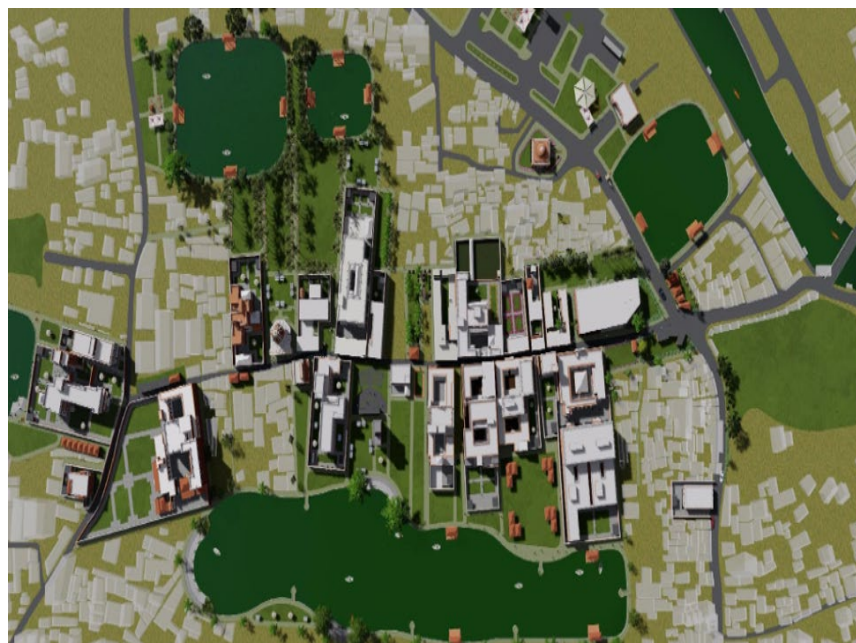
***Fig.13 Shows: Proposed Master Plan of Adaptive Revitalization of Nagar Khasa***

The proposed spatial framework includes a core conservation zone containing the most significant heritage structures, an adaptive-reuse zone for vacant or underused buildings, a public-realm improvement zone along major pedestrian routes, a cultural-event zone around ritual and gathering spaces, and a modest tourism-service zone near accessible entry points. Water bodies and ghats should form an environmental protection zone, while surrounding areas should function as compatible-development buffers. Building-level interventions should be determined by condition and significance. Measures may include emergency stabilization, preventive maintenance, structural repair, façade conservation, removal of incompatible additions, courtyard restoration, and controlled adaptive reuse. New development should respect existing height, scale, frontage, materials, and street character (Arfa et al., 2022; Australia ICOMOS, 2013; Yung & Chan, 2012).

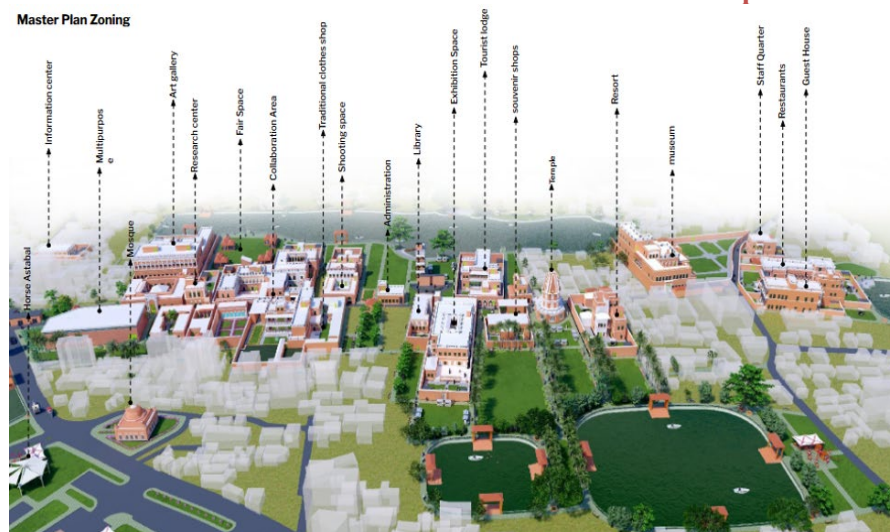
*Fig.14 Shows: Proposed Master Plan of Adaptive Revitalization of Nagar Kasba*

A connected pedestrian heritage trail should link important houses, religious buildings, courtyards, cultural spaces, ghats and water bodies. Directional signs and interpretation panels should communicate local history without obstructing historic façades. Public-realm improvements should include accessible pathways, shaded resting areas, sensitive lighting, waste collection, landscape restoration, traffic control and emergency access. Ghat rehabilitation and water-body protection should address drainage, pollution, erosion, ritual use and ecological quality. The pathway, streetscape and perspective views in Figure 10 are conceptual visualizations rather than construction documents; alignment, dimensions, materials and access arrangements require measured survey, engineering review and community approval (ICOMOS, 2022; Landorf, 2009; Mukherjee et al., 2022).

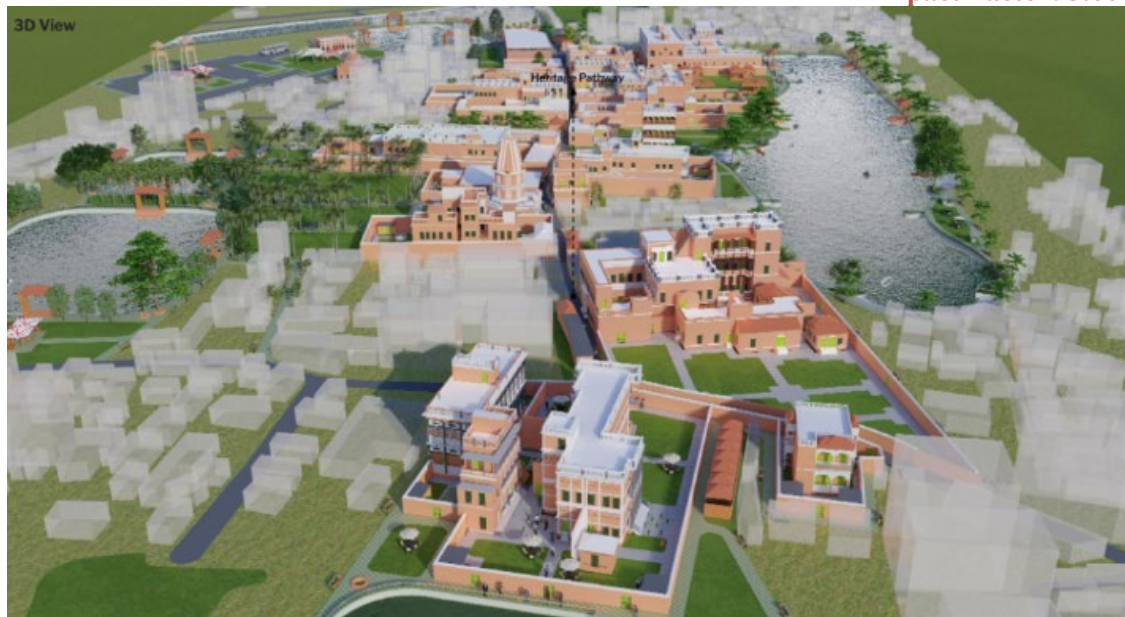
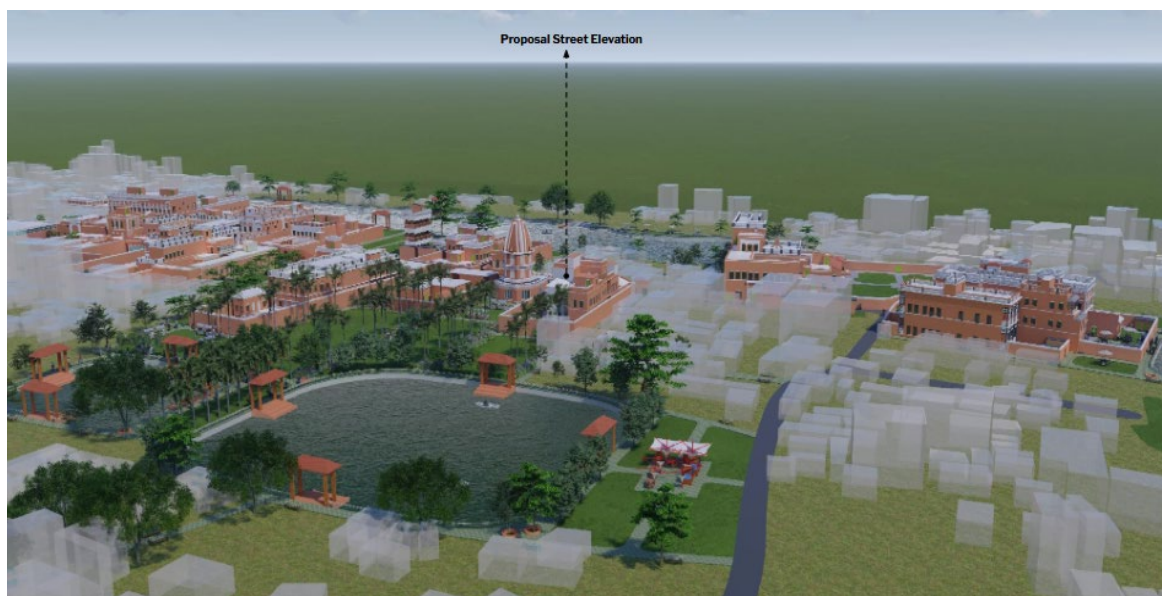
*Figure 15 and 16 Shows. Integrated regeneration proposal: (a) filtered conservation and adaptive-reuse zoning, (b) conceptual heritage pathway, (c) proposed street improvement and (d) adaptive-reuse perspective. All three-dimensional views are conceptual scenarios and require measured survey, structural review, community approval and detailed conservation design.*

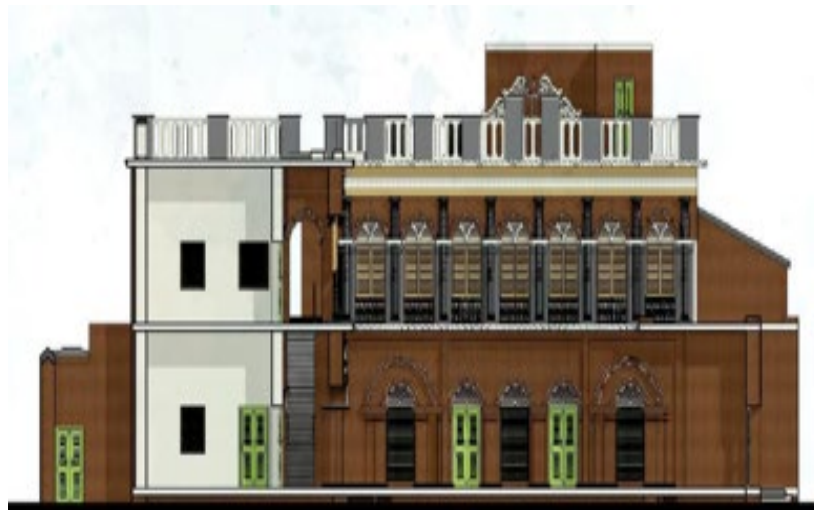
**Figure 24 Shows:** Proposed east elevation of the selected Haque House adaptive-reuse case. Scale,

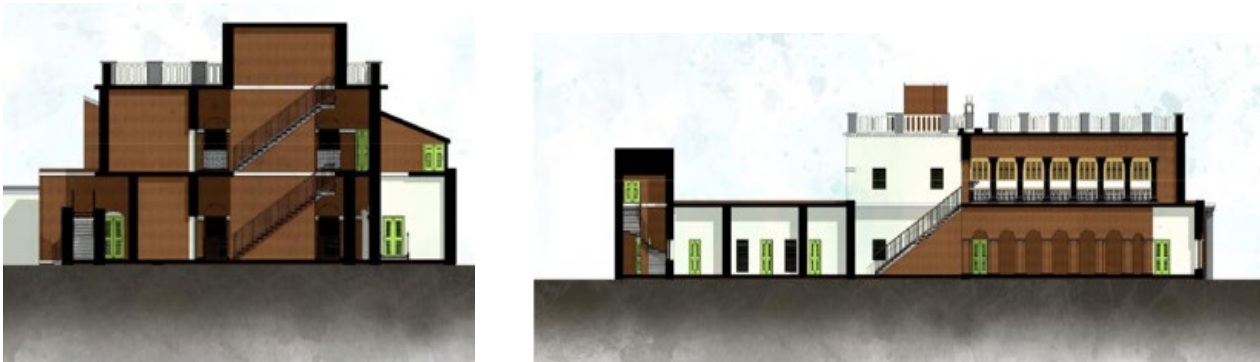
*Figure 25& 26 Shows: Section Shows Spatial Analysis and Functional Structure of Haque House*
